**On the Ductile Failure of Thin-Walled Aluminum Alloy Tubes
Under Combined Shear and Tension**

Thesis

**The University of Texas at Austin
December 2012**

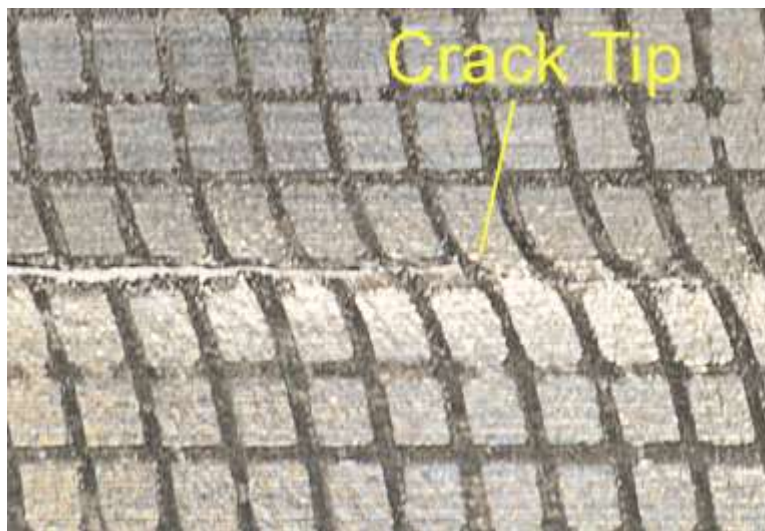
Figure 3.9: Expanded images of the grid taken at the end of the $\alpha = 1.5$ test showing the localized zone and crack extending from the right (a) and from the left (b).

was unloaded and detailed photographs were taken of the cracked region. Figure 3.9 shows two close up photographs of the crack, taken on either end of the crack. One can clearly see the discontinuity and the variation of deformation along the vertical direction within the images.

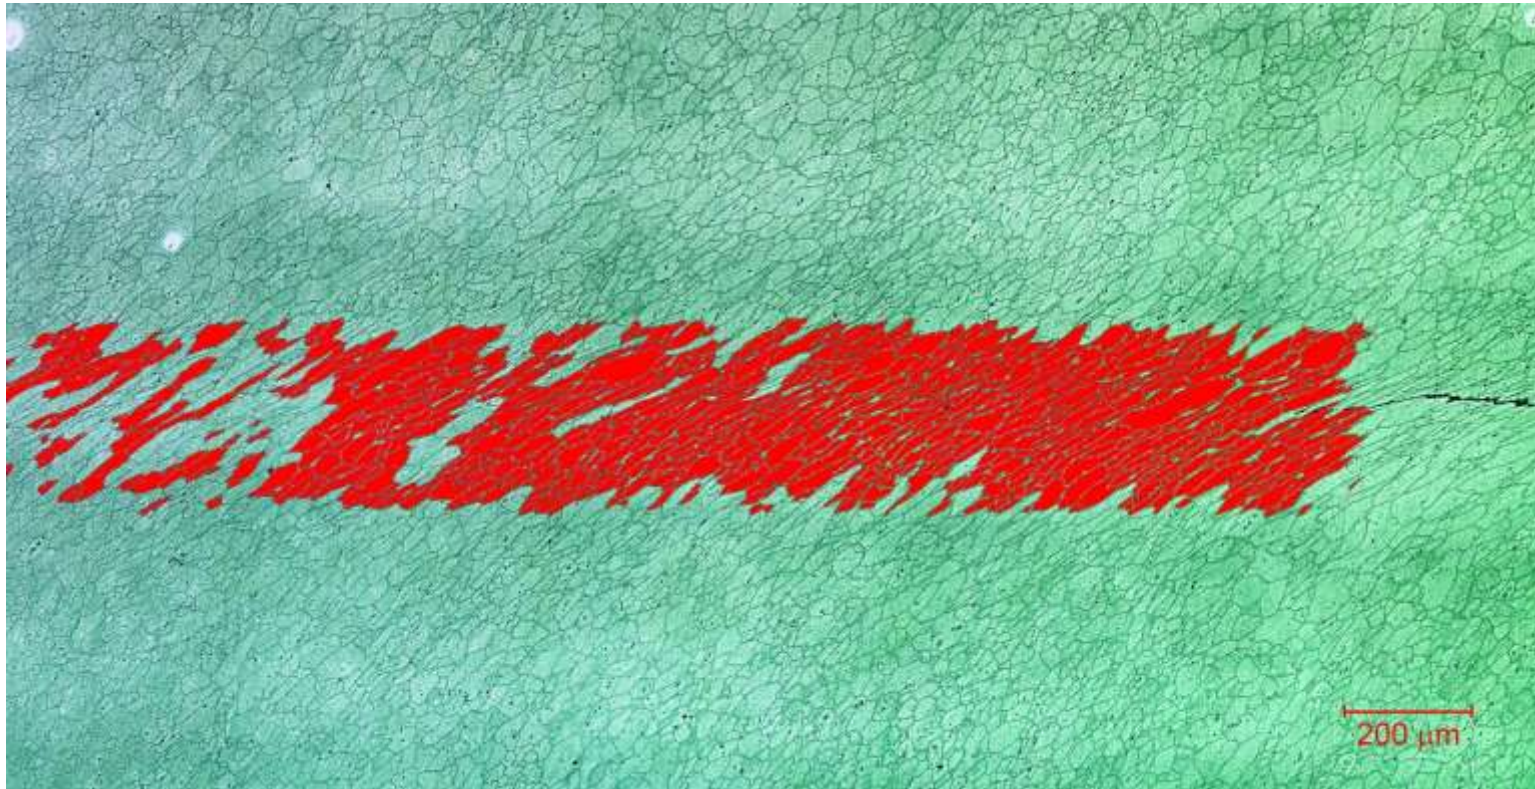
Figure 4.5: Micrograph showing a planar view of the deformed grain microstructure after failure for $\alpha = 0.75$; on the right is the crack (vertical along the axis of the tube). The red grains are used to estimate the grain level deformation- DC13.

The procedure of extracting grain-level strains will be described through results for $\alpha = 0.75$. Figure 4.5 shows a composite micrograph that contains on the right one of the tips of the crack formed. It is approximately $2400 \mu\text{m}$ wide by $1200 \mu\text{m}$ tall with the

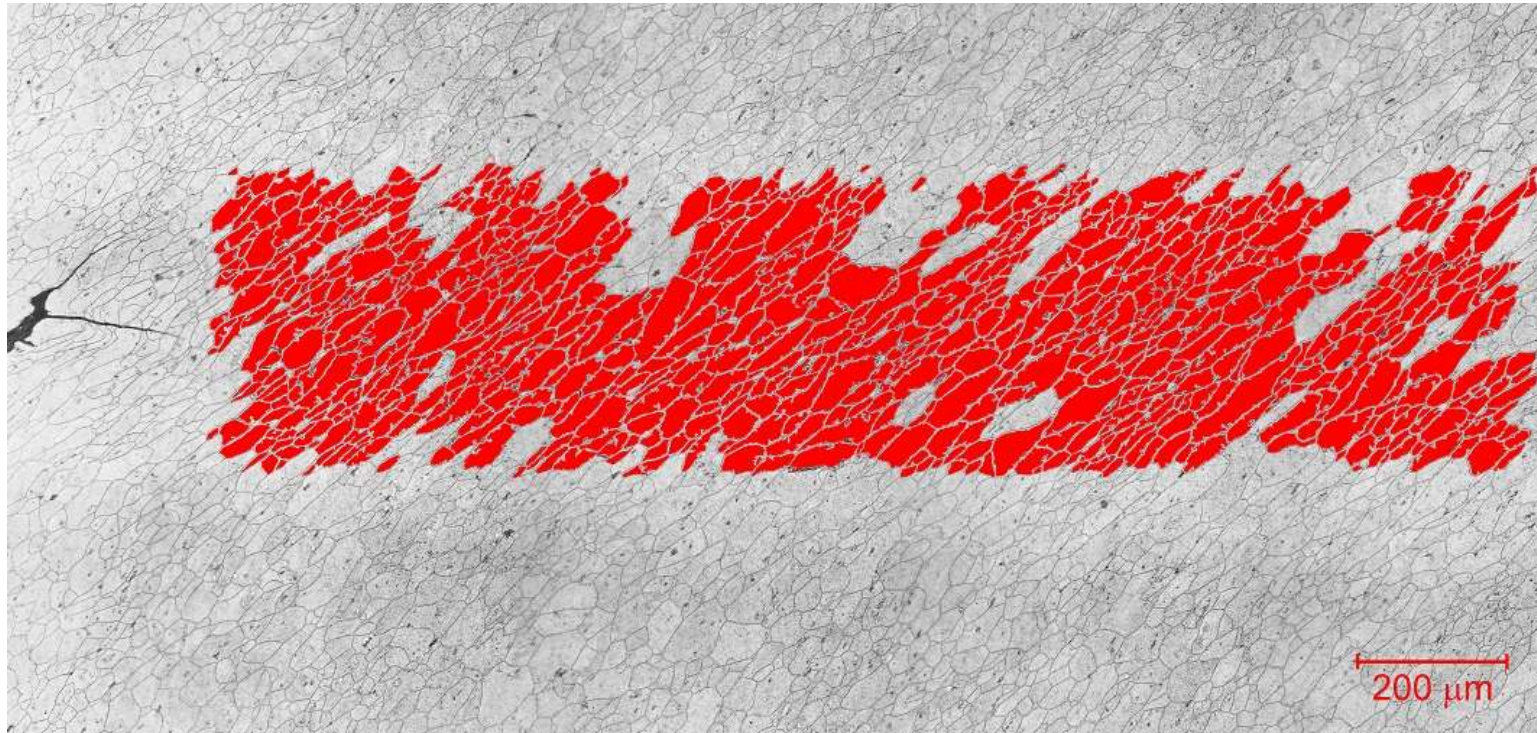
Figure 4.13: Micrograph showing a planar view of the deformed grain microstructure after failure for $\alpha = 1.0 \sigma \rightarrow \tau$; on the left is the crack (vertical along the axis of the tube). The red grains are used to estimate the grain level deformation- DC13.

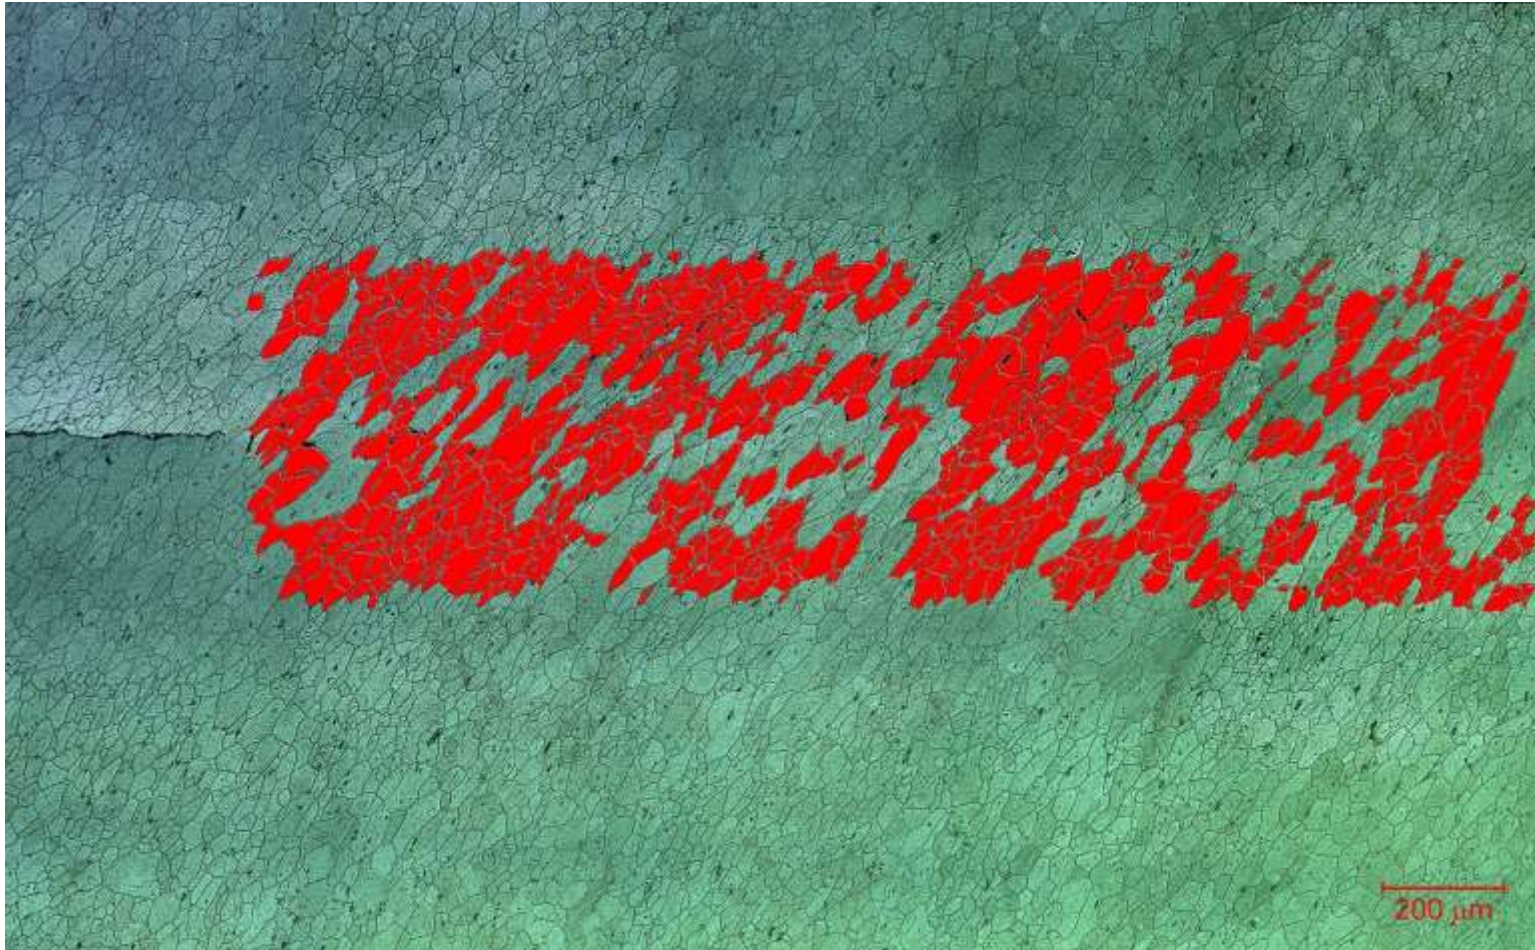
Figure 4.16: Micrograph showing a planar view of the deformed grain microstructure after failure for $\alpha = 1.5$; on the left is the crack (vertical along the axis of the tube). The red grains are used to estimate the grain level deformation- DC13.

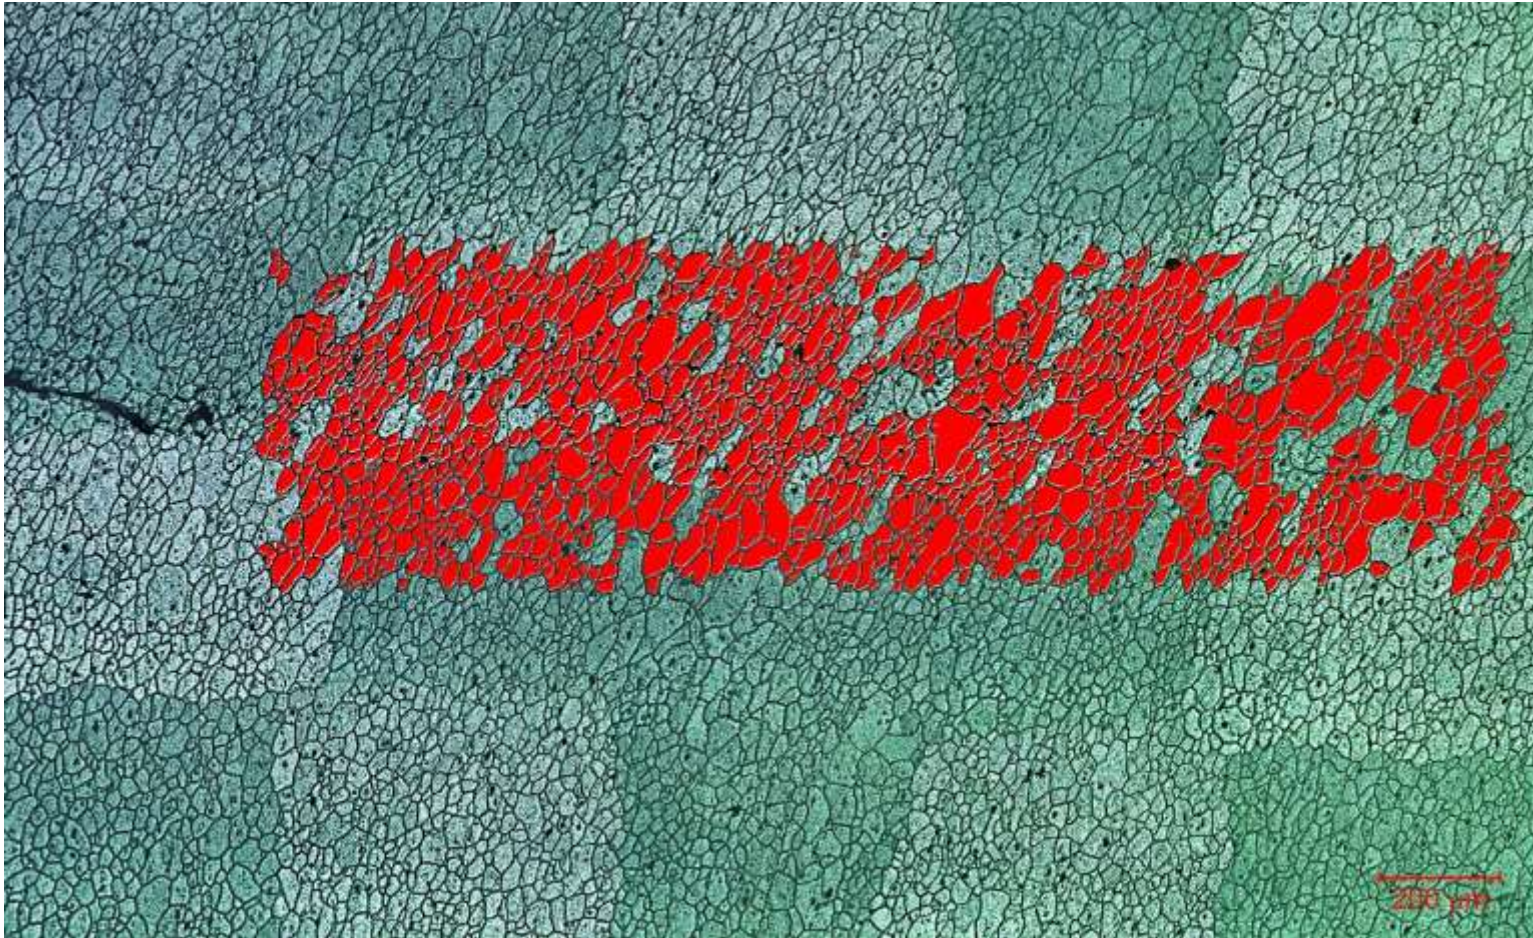
Figure 4.19: Micrograph showing a planar view of the deformed grain microstructure after failure for $\alpha = 2.0$; on the left is the crack (vertical along the axis of the tube). The red grains are used to estimate the grain level deformation- DC13.
